U.S. Department
of Transportation
**Federal Highway
Administration**

Guardrail Testing Program

Final Report

Publication No. FHWA-RD/FLP-90-087
May 1990

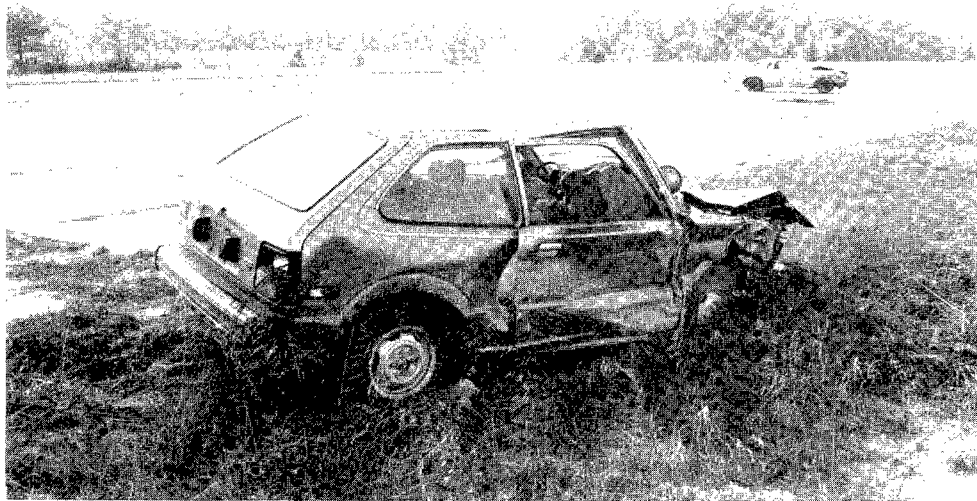
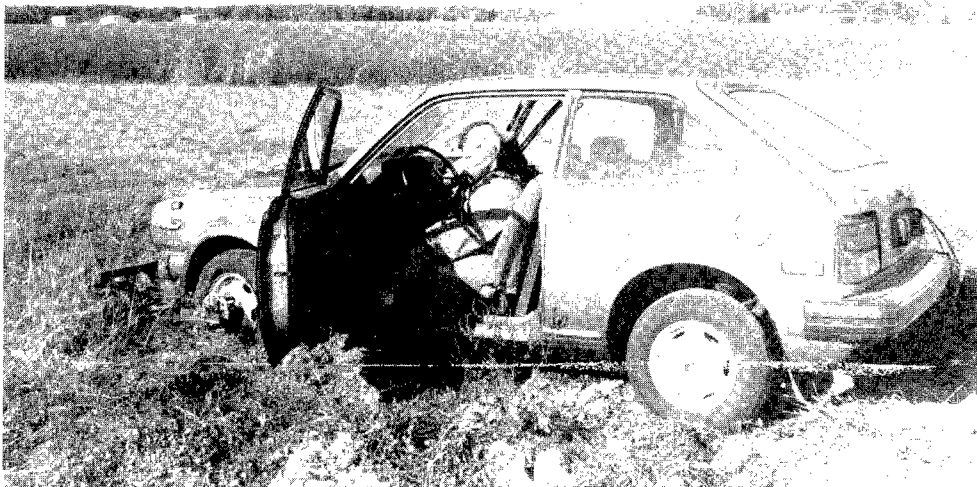
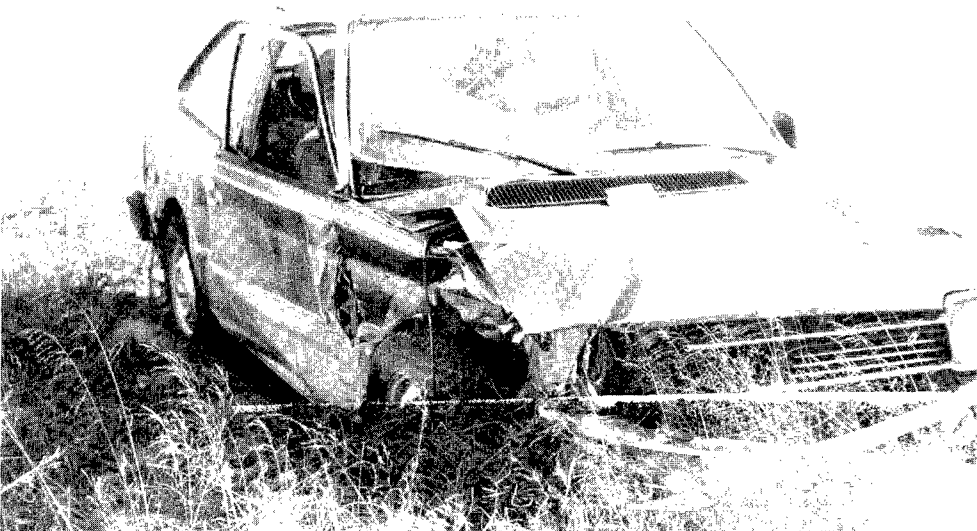
Figure 33. Posttest photographs of test vehicle,
test 1818-5-3-87.

Vehicle damage occurred mainly to the right front fender, grill and bumper. The front right tire rim was damaged from impacting the wall, resulting in a flat tire. The passenger side door was wedged outward and the windshield was shattered on the passenger side due to the impact from the dummy. Windshield fragments were thrown 35 to 40 ft (10.7 to 12.2 m) behind the guardwall. Posttest photographs of the vehicle are shown in figure 33.

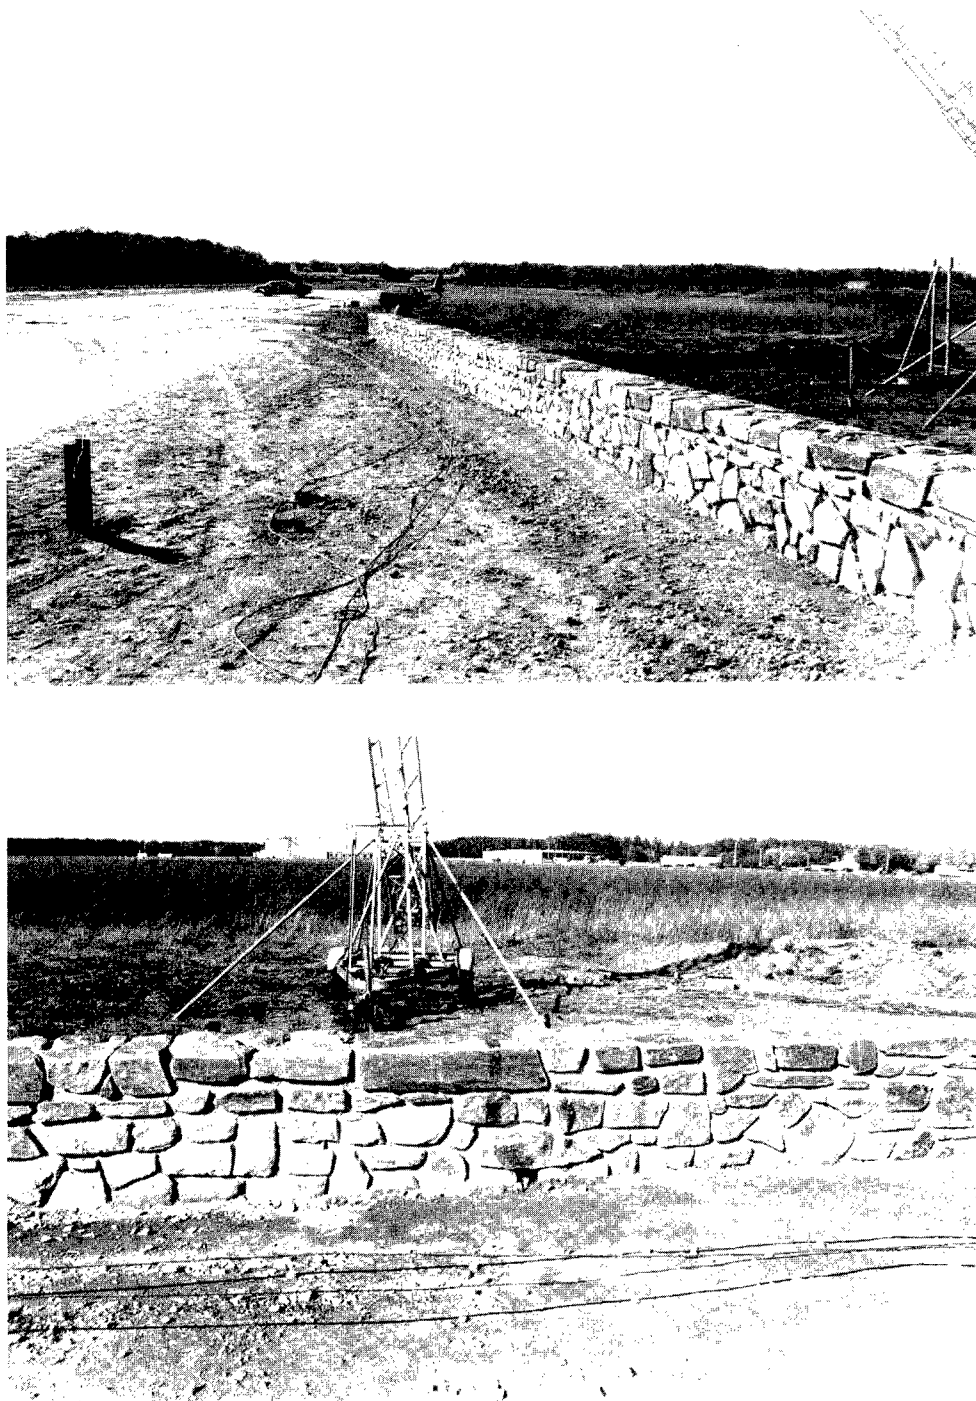
Figure 34. Posttest photographs of guardwall system,
test 1818-5-3-87.

As summarized in the full-scale test section, task E, the stone masonry guardwall was structurally inadequate under NCHRP 230 test 10 conditions. 15 ft (4.6 m) of coping stone was knocked 5 ft (1.53 m) behind the wall, 4 ft (1.22 m) of coping stone was angled back, and a one-piece coping stone was dislodged. Given that standard bumper heights for large sedans are 18 in (0.46 m) at the bumper center and the core height is 18 in (0.46 m) above ground level, the weakest point of the system is at the vertical impact point. The following recommendations are made to improve this design:

Upon impact, the front of the vehicle was deformed and skewed toward the non-impact side. The right front corner of the vehicle continued to crush. The vehicle rode up on top of the wall, knocking off approximately 15 ft (4.6 m) of coping stone.

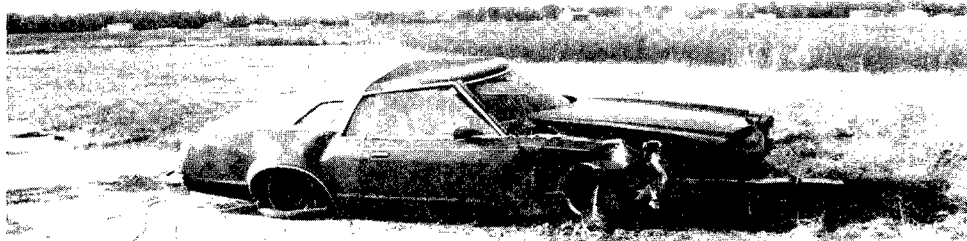
Figure 41. Posttest photographs of test vehicle,
test 1818-5-4-87.

Vehicle damage occurred mainly to the right side of the car. The right front fender, grill, bumper, rear quarterpanel, and vehicle steering and suspension were damaged significantly. The two right wheels were damaged from impacting the rail thus, resulting in flat tires. The passenger side door was wedged outward and the windshield was shattered on the passenger side due to the impact from the dummy. Posttest photographs of the vehicle are shown in figure 41.

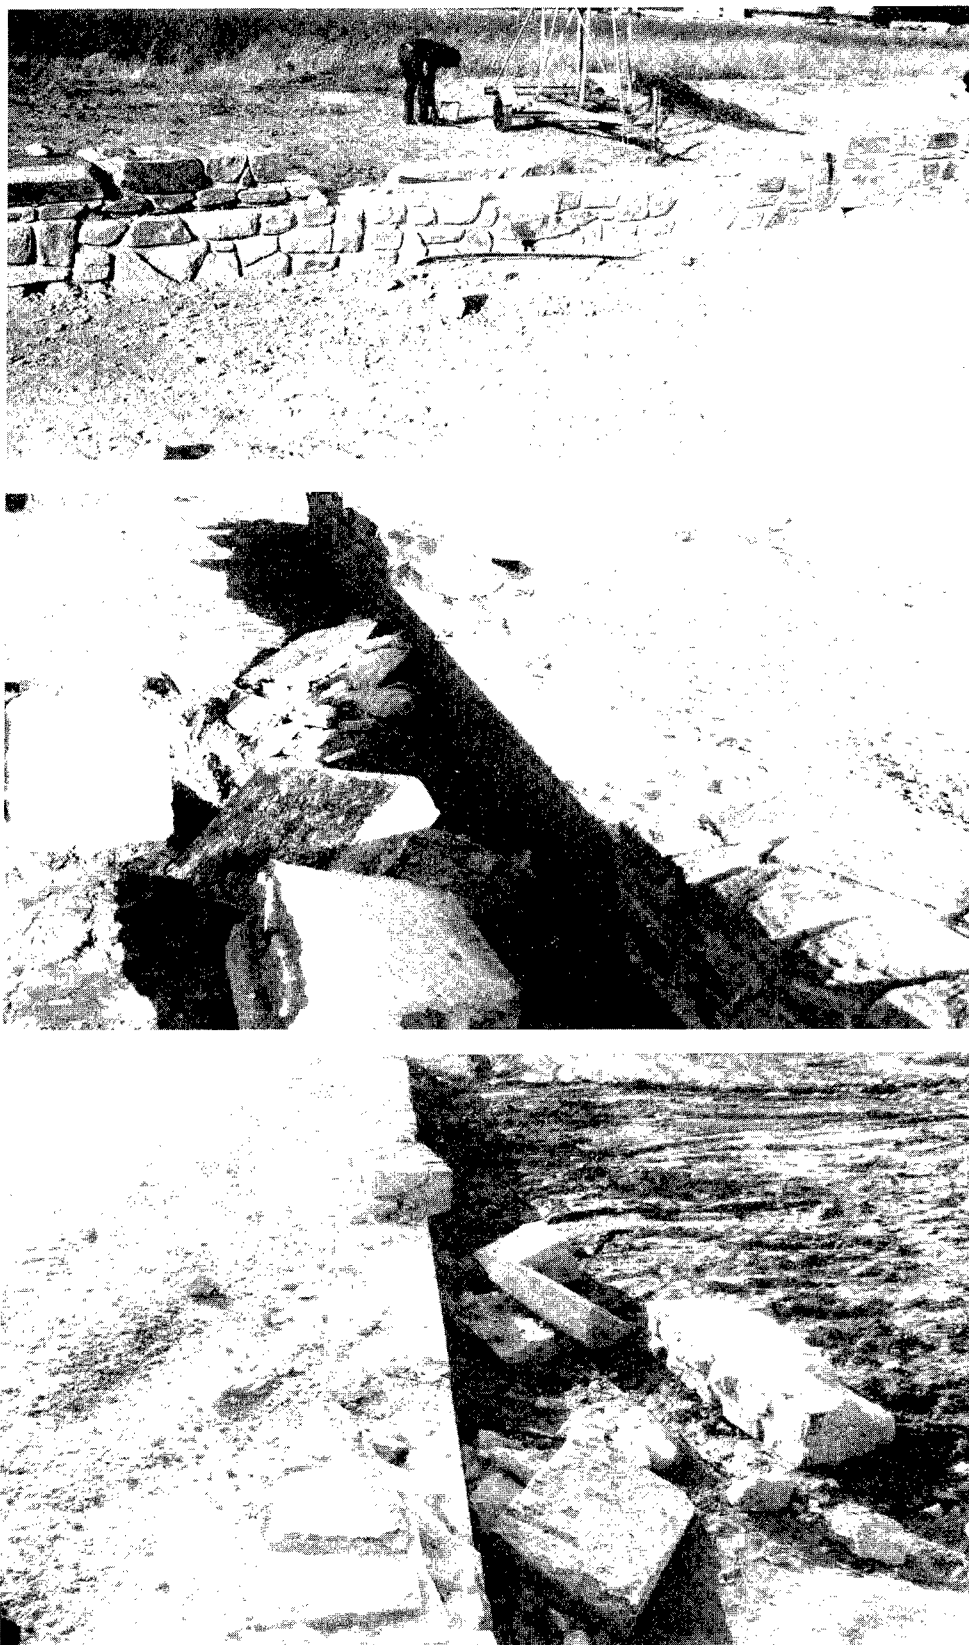
Figure 42. Posttest photographs of guardwall system,
test 1818-5-4-87.

Vehicle rode up on guardwall and was redirected. Significant damage occurred to guardwall - 20 ft of coping stone knocked off top of wall. Vehicle was redirected by the guardwall at 36.4 mi/h and 4 degrees. Because the vehicle did not intrude or come to rest in the adjacent traffic lanes, the vehicle slowdown criteria does not apply.

Upon impact, the front of the vehicle was deformed and skewed toward the non-impact side. The hood came open just after impact. The passenger side door bent open but did not come unlatched. The right front corner of the vehicle continued to crush until the vehicle A-pillar struck the wall. The vehicle then yawed around and exited the wall. The vehicle remained in

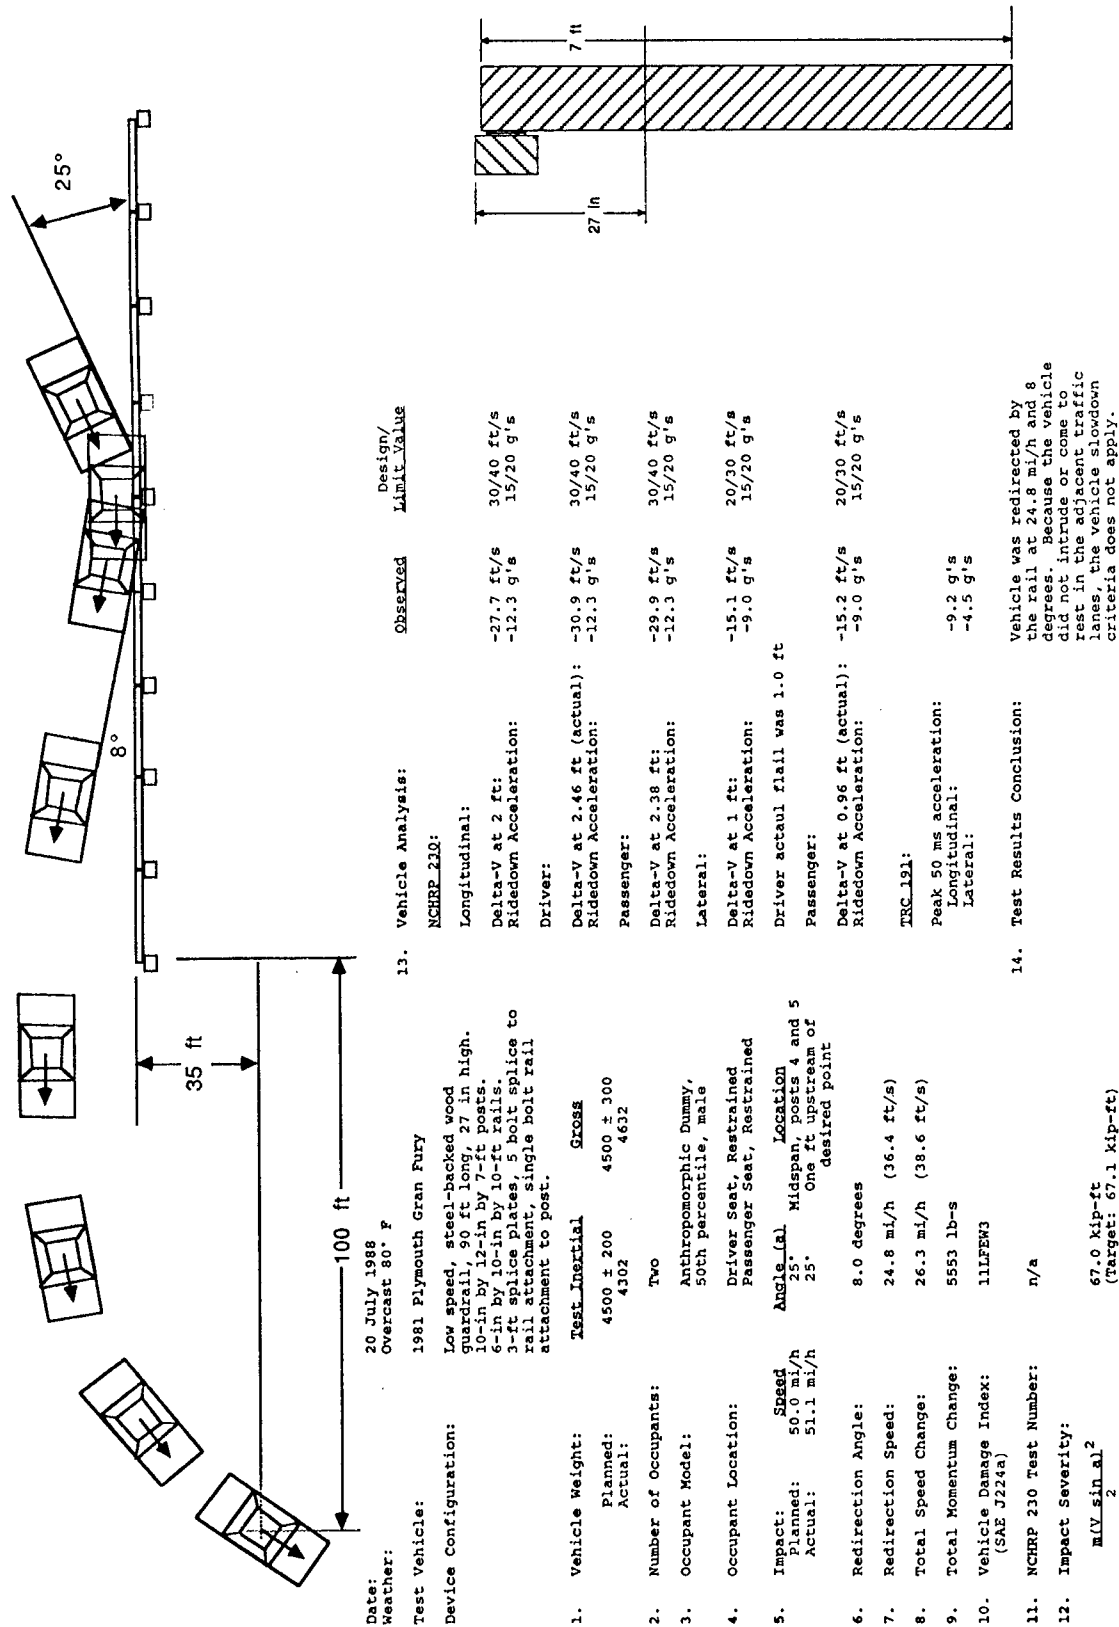
Figure 94. Test summary, test 1818-14-88.

This guardrail performed adequately. The vehicle getting under the rail caused the rail to rise. The left front wheel of the vehicle was torn from the car in the impact with post 5. Posts 4 and 6 were pushed back 1 in (0.03 m) and post 5 was pushed back 5 in (0.13 m). Posttest photographs of the guardrail are shown in figure 97.
